**BAREFOOT BEACH SURVEY & ANALYSIS
JULY 2018**

BAREFOOT BEACH PROPERTY OWNERS ASSOCIATION

PREPARED BY
HUMISTON & MOORE ENGINEERS
H&M FILE 28013

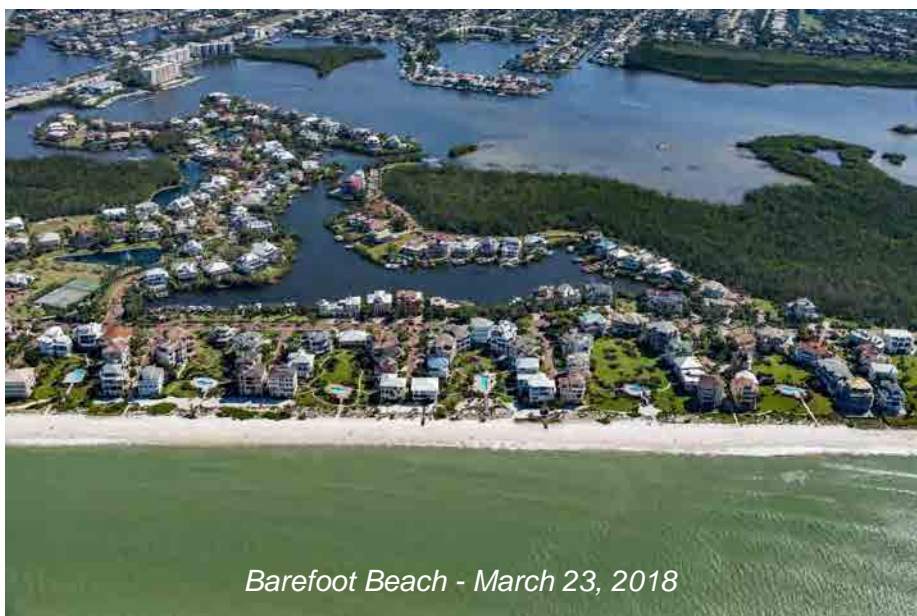
Barefoot Beach - March 23, 2018

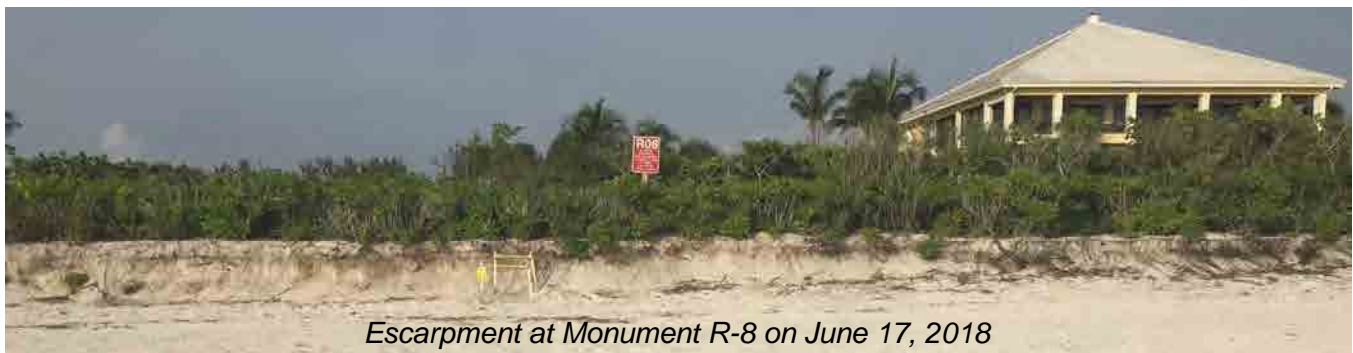
FIGURE 2: BAREFOOT BEACH PROVISIONAL BASELINE

Escarpment at Monument R-8 on June 17, 2018

Historically surveys of Barefoot Beach have been conducted at the DEP reference monuments shown in **Figure 2**, overlaid on an aerial image acquired on December 2, 2017, and along the profile lines shown at each monument. The analysis in this monitoring report is based on data from the surveys listed below and shown graphically in the beach profiles contained in **Appendix E**.

Table 4 shows the width of the dry beach as measured from the *provisional baseline* (shown in **Figure 2**) to the MHWL for DEP reference monuments R-1 to R-9 from 2000 to the most recent survey in 2017. The highest average width was in 2000 and 2015 with the reach averaging 91 feet in width. **Table 5** shows the shoreline (or beach width) change for the same monuments and time span. The impact of Tropical Storm Leslie and Hurricane Gabrielle was likely a major cause of the shoreline recession from 2000-2003 with all of the monuments losing dry beach width during this period. The average beach width narrowed by 14 feet (-14) from 91 to 77 feet but recovered by 2015 gaining back all 14 feet over the following 12 years only to be impacted by Hurricane Irma in 2017 losing an average width of 9 feet (-9) for the entire reach. Considering the 17 year span from 2000 to 2017 the majority of the loss in beach width is from monuments R-3 to R-6 inclusive, losing an average of 18 feet in width (-18) while the balance of the reach remained relatively stable.

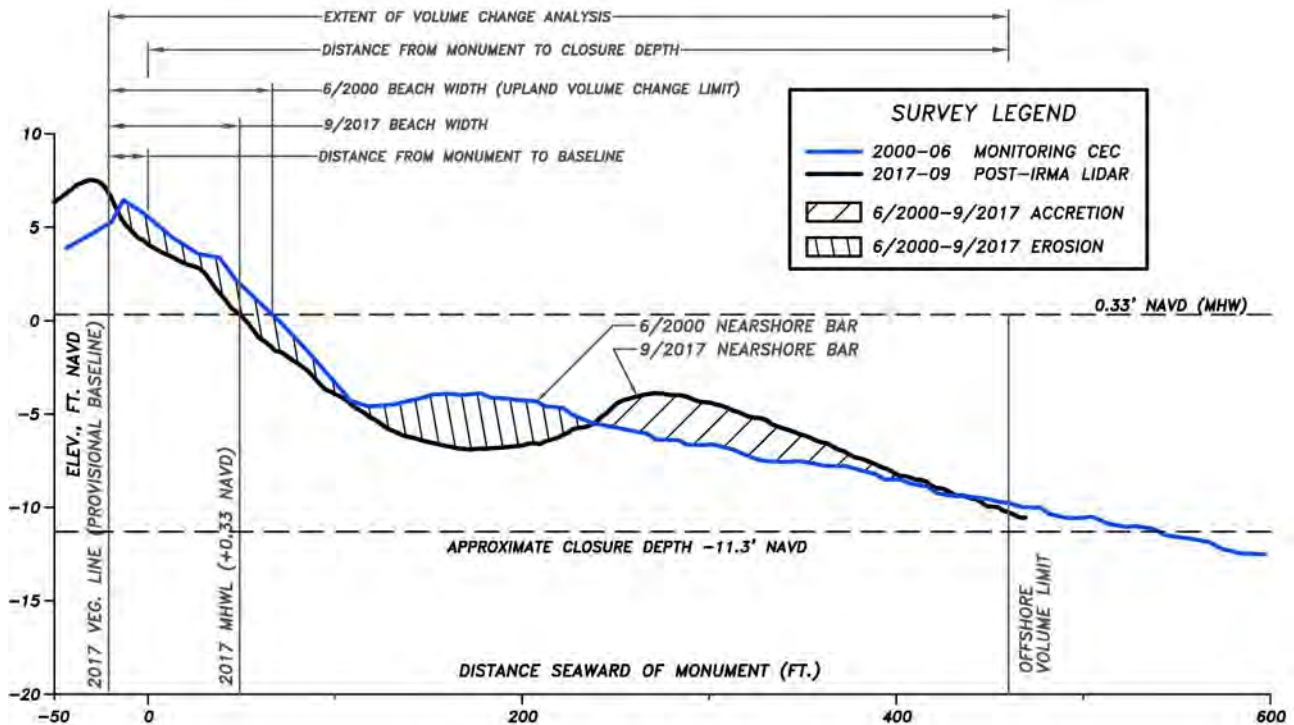
Figure 3a. Typical Beach Profile Comparison

Figure 3a shows a typical beach profile comparison for the survey conducted in 2000, and most recently in September 2017 with the elevation (referencing the NAVD vertical datum) on the vertical axis and the distance from monument (in feet) on the horizontal axis. Additionally, the bounds of the shore-normal limits for the volume analysis described in **Table 2** (and **Table 7**) along with the corresponding beach widths are included. The area change at this monument from the 6/2000 to 9/2017 surveys, denoting accretion and erosion, averaged with the area change at each adjacent monument is multiplied by the distance between the monuments to obtain the net volume change between adjacent monuments.

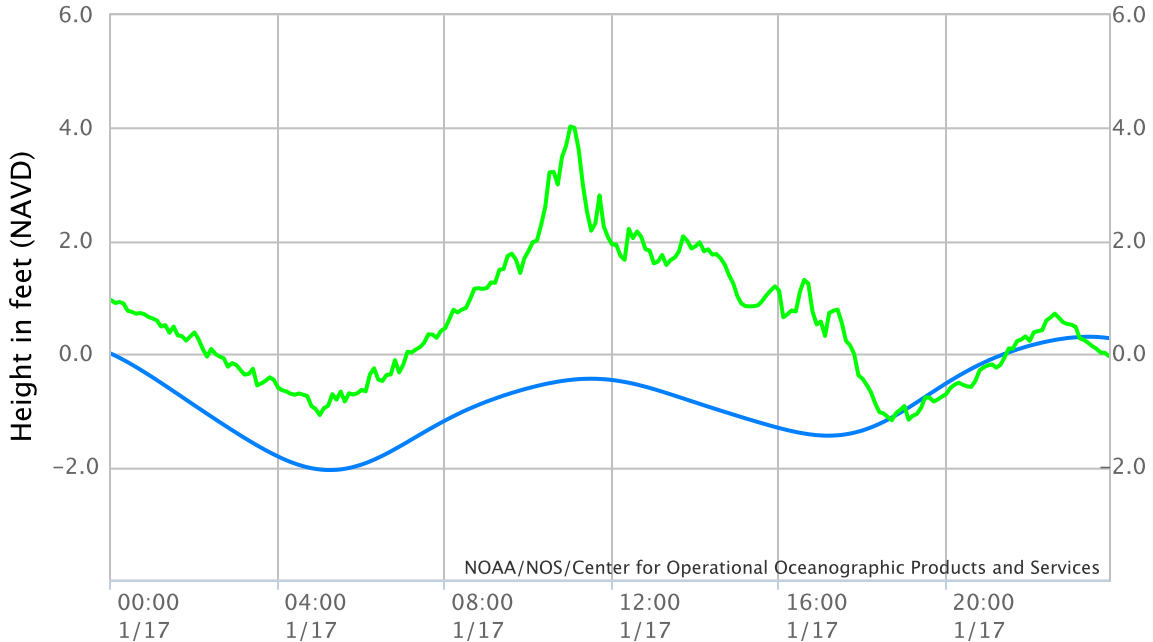
NOAA/NOS/CO-OPS
Observed Water Levels at 8725110, Naples FL
From 2016/01/17 00:00 GMT to 2016/01/17 23:59 GMT

Additionally Collier County was impacted by Tropical Storm Leslie in October 2000 and a meteotsunami⁴ in January 2016. A graph of the observed water levels at the Naples Tide Station on January 17, 2016 documenting the meteostunami and the storm track for Hurricane Irma is included in **Appendix A**.

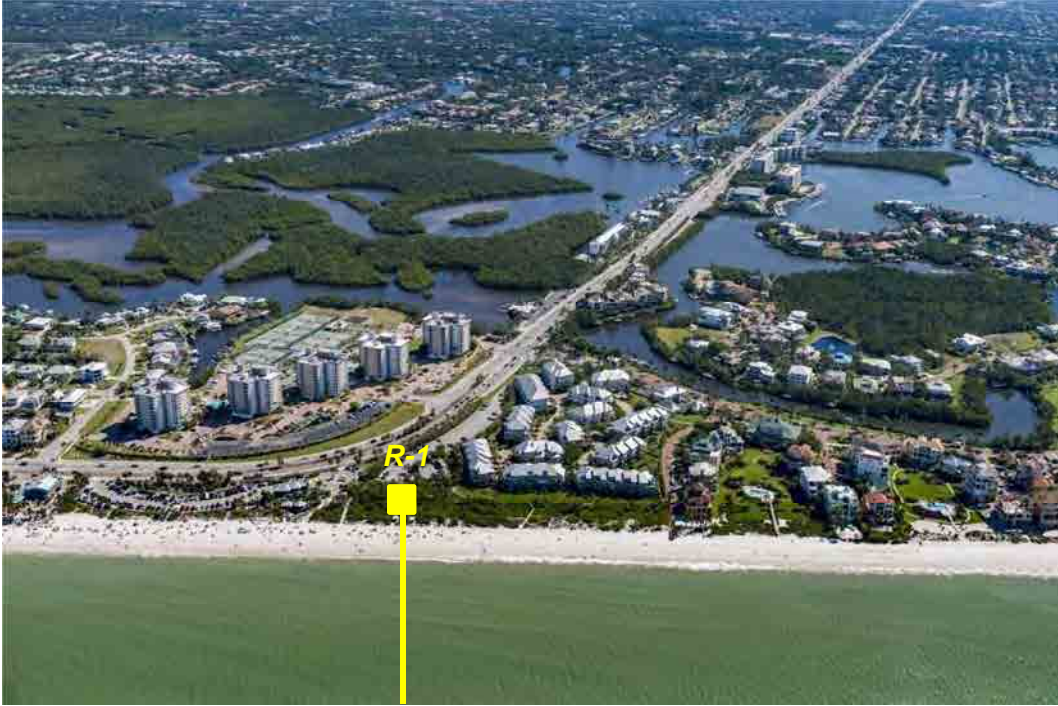
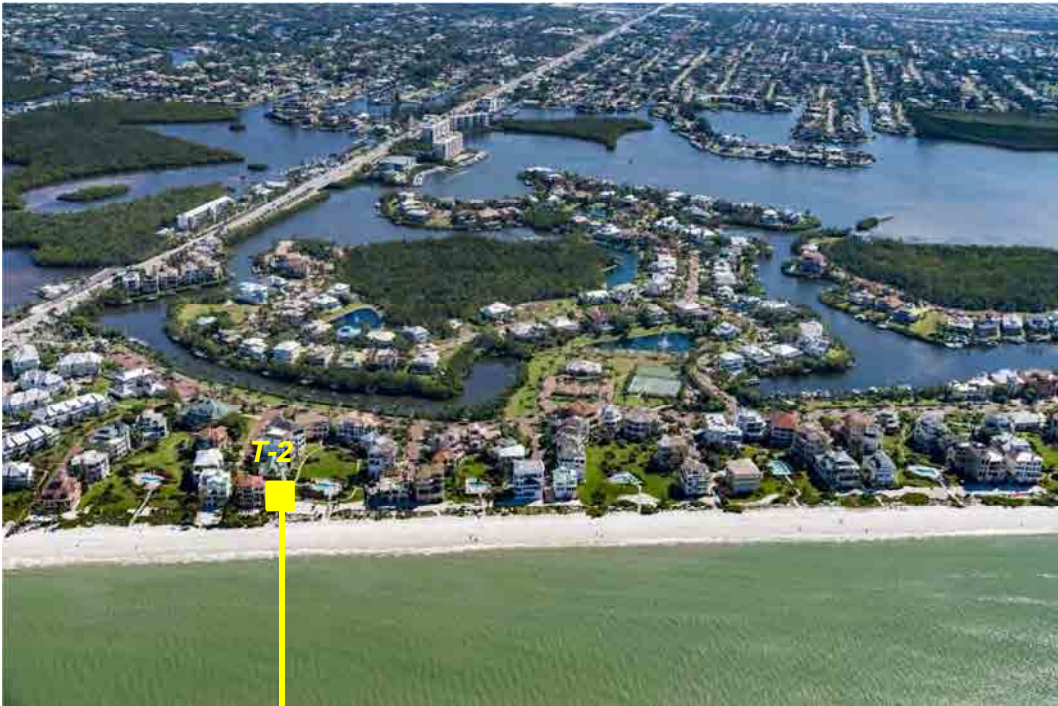
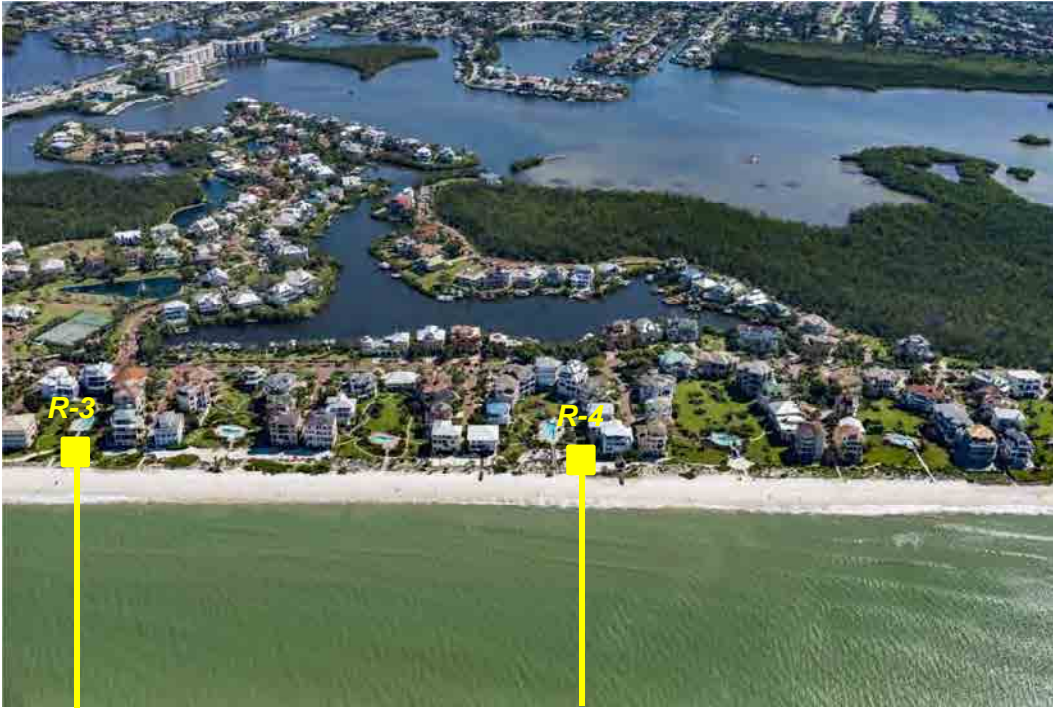
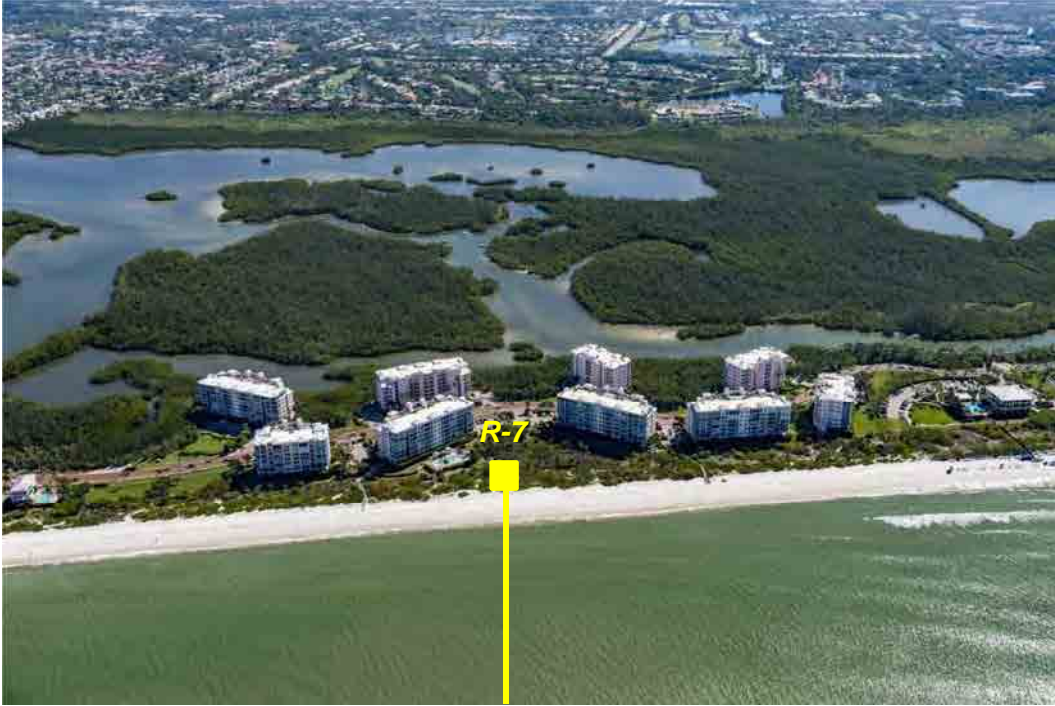
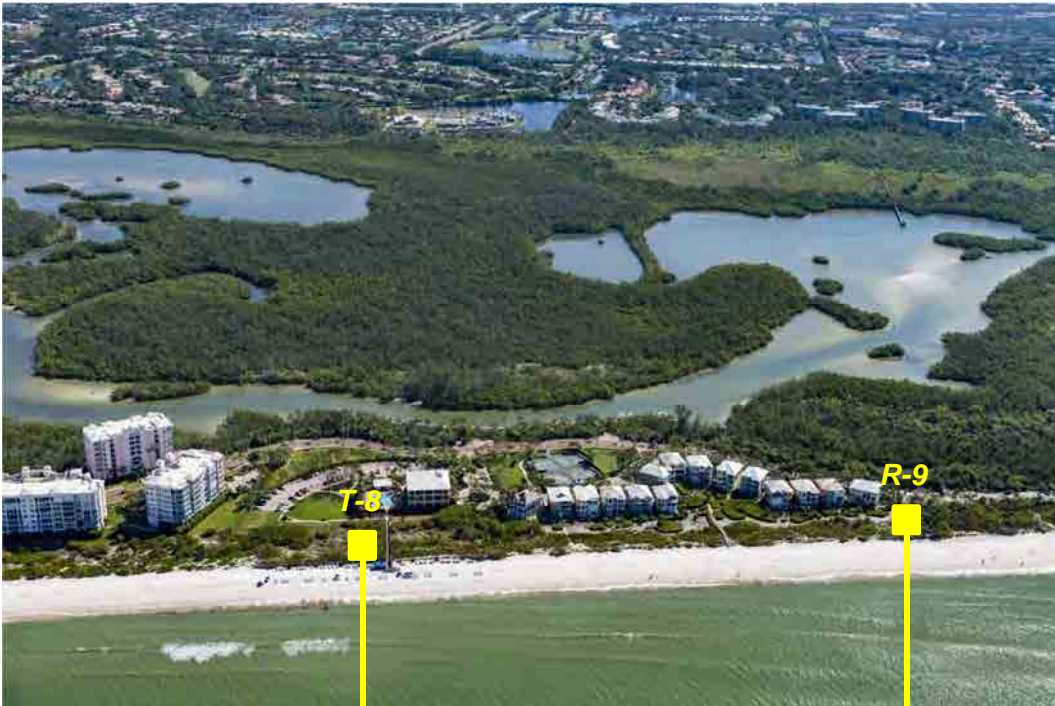
Aerial Photographs taken on March 23, 2018

Barefoot Beach - March 28, 2018

Tropical Storm Alberto recently impacted Barefoot Beach on May 26, 2018. The photographs provided in **Appendix C** indicate additional loss in beach width beyond the losses documented by surveys as a consequence of Hurricane Irma. Many of the dune walkovers are in need of repair as well as the signs showing the location of the “R” monuments. An escarpment can be noted near monument R-8 in the photographs as well as the beach profile provided in **Appendix E**.

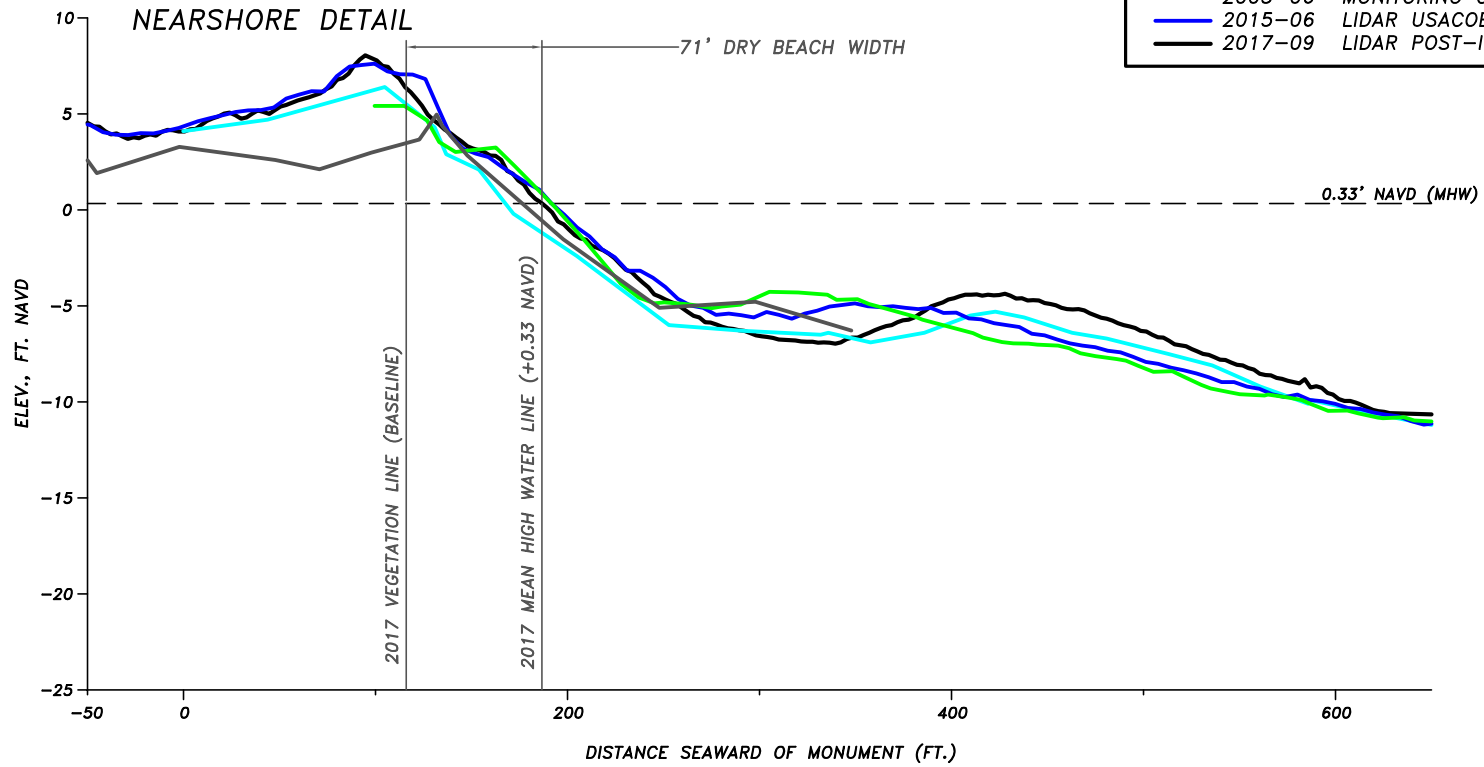
BEACH PROFILE: R-2

SURVEY LEGEND	
— (Black)	1973-03 MONITORING DEP
— (Green)	2000-06 MONITORING DEP 48-MO POST
— (Cyan)	2003-06 MONITORING CP&E
— (Blue)	2015-06 LIDAR USACOE
— (Black)	2017-09 LIDAR POST-IRMA USACOE

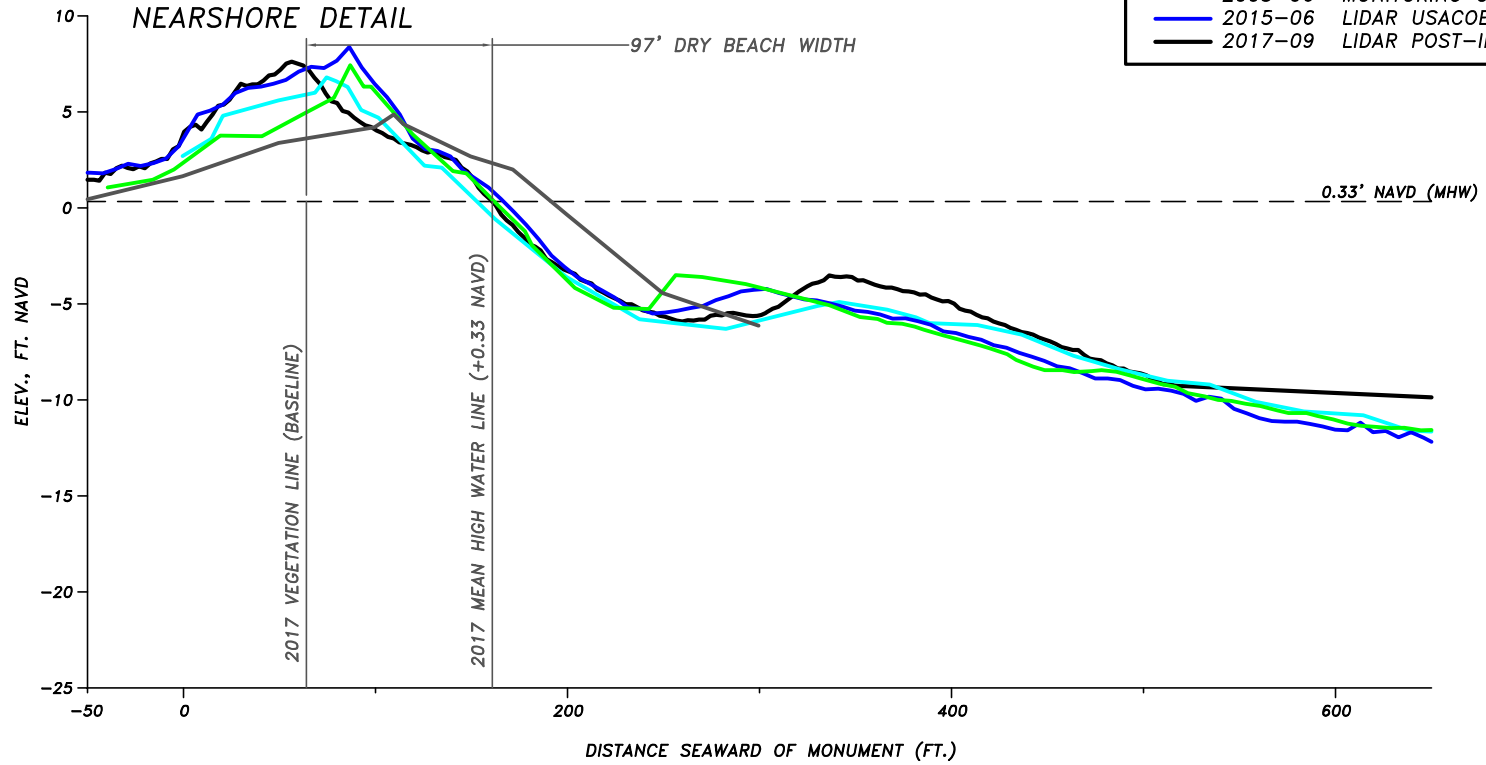
BEACH PROFILE: R-7

SURVEY LEGEND	
— (Black)	1973-03 MONITORING DEP
— (Green)	2000-06 MONITORING DEP 48-MO POST
— (Cyan)	2003-06 MONITORING CP&E
— (Blue)	2015-06 LIDAR USACOE
— (Black)	2017-09 LIDAR POST-IRMA USACOE

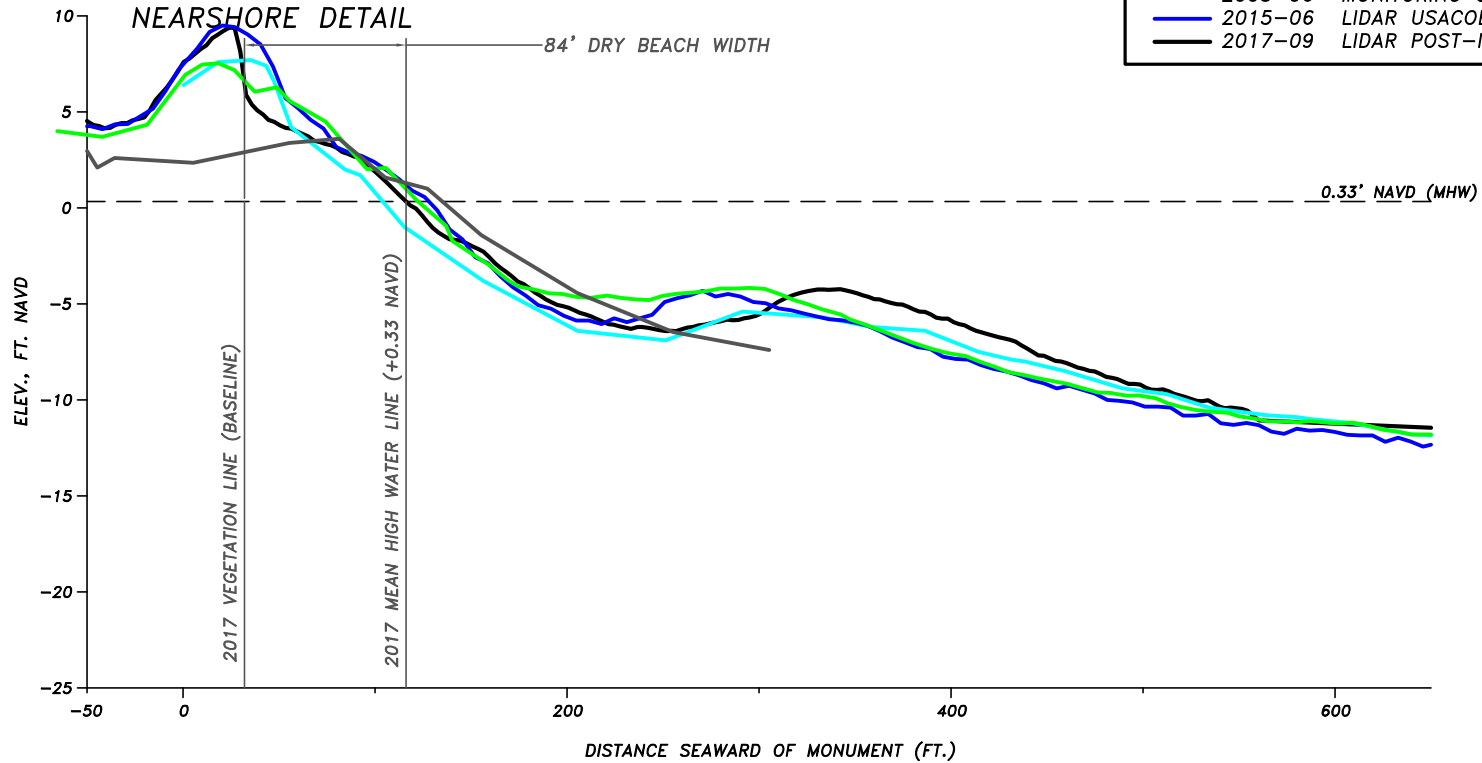
BEACH PROFILE: R-8

SURVEY LEGEND	
—	1973-03 MONITORING DEP
—	2000-06 MONITORING DEP 48-MO POST
—	2003-06 MONITORING CP&E
—	2015-06 LIDAR USACOE
—	2017-09 LIDAR POST-IRMA USACOE
