Re: Barefoot Beach, Collier County

The Division's coastal engineering staff have completed a review of your document – *Barefoot Beach Survey & Analysis, July 2018*. The analysis is very comprehensive and we agree with the data and computations for the northern segment of beach in Collier County extending between the Department of Environmental Protection reference monuments R1 and R9.

COLLIER Post-Irma LIDAR Survey

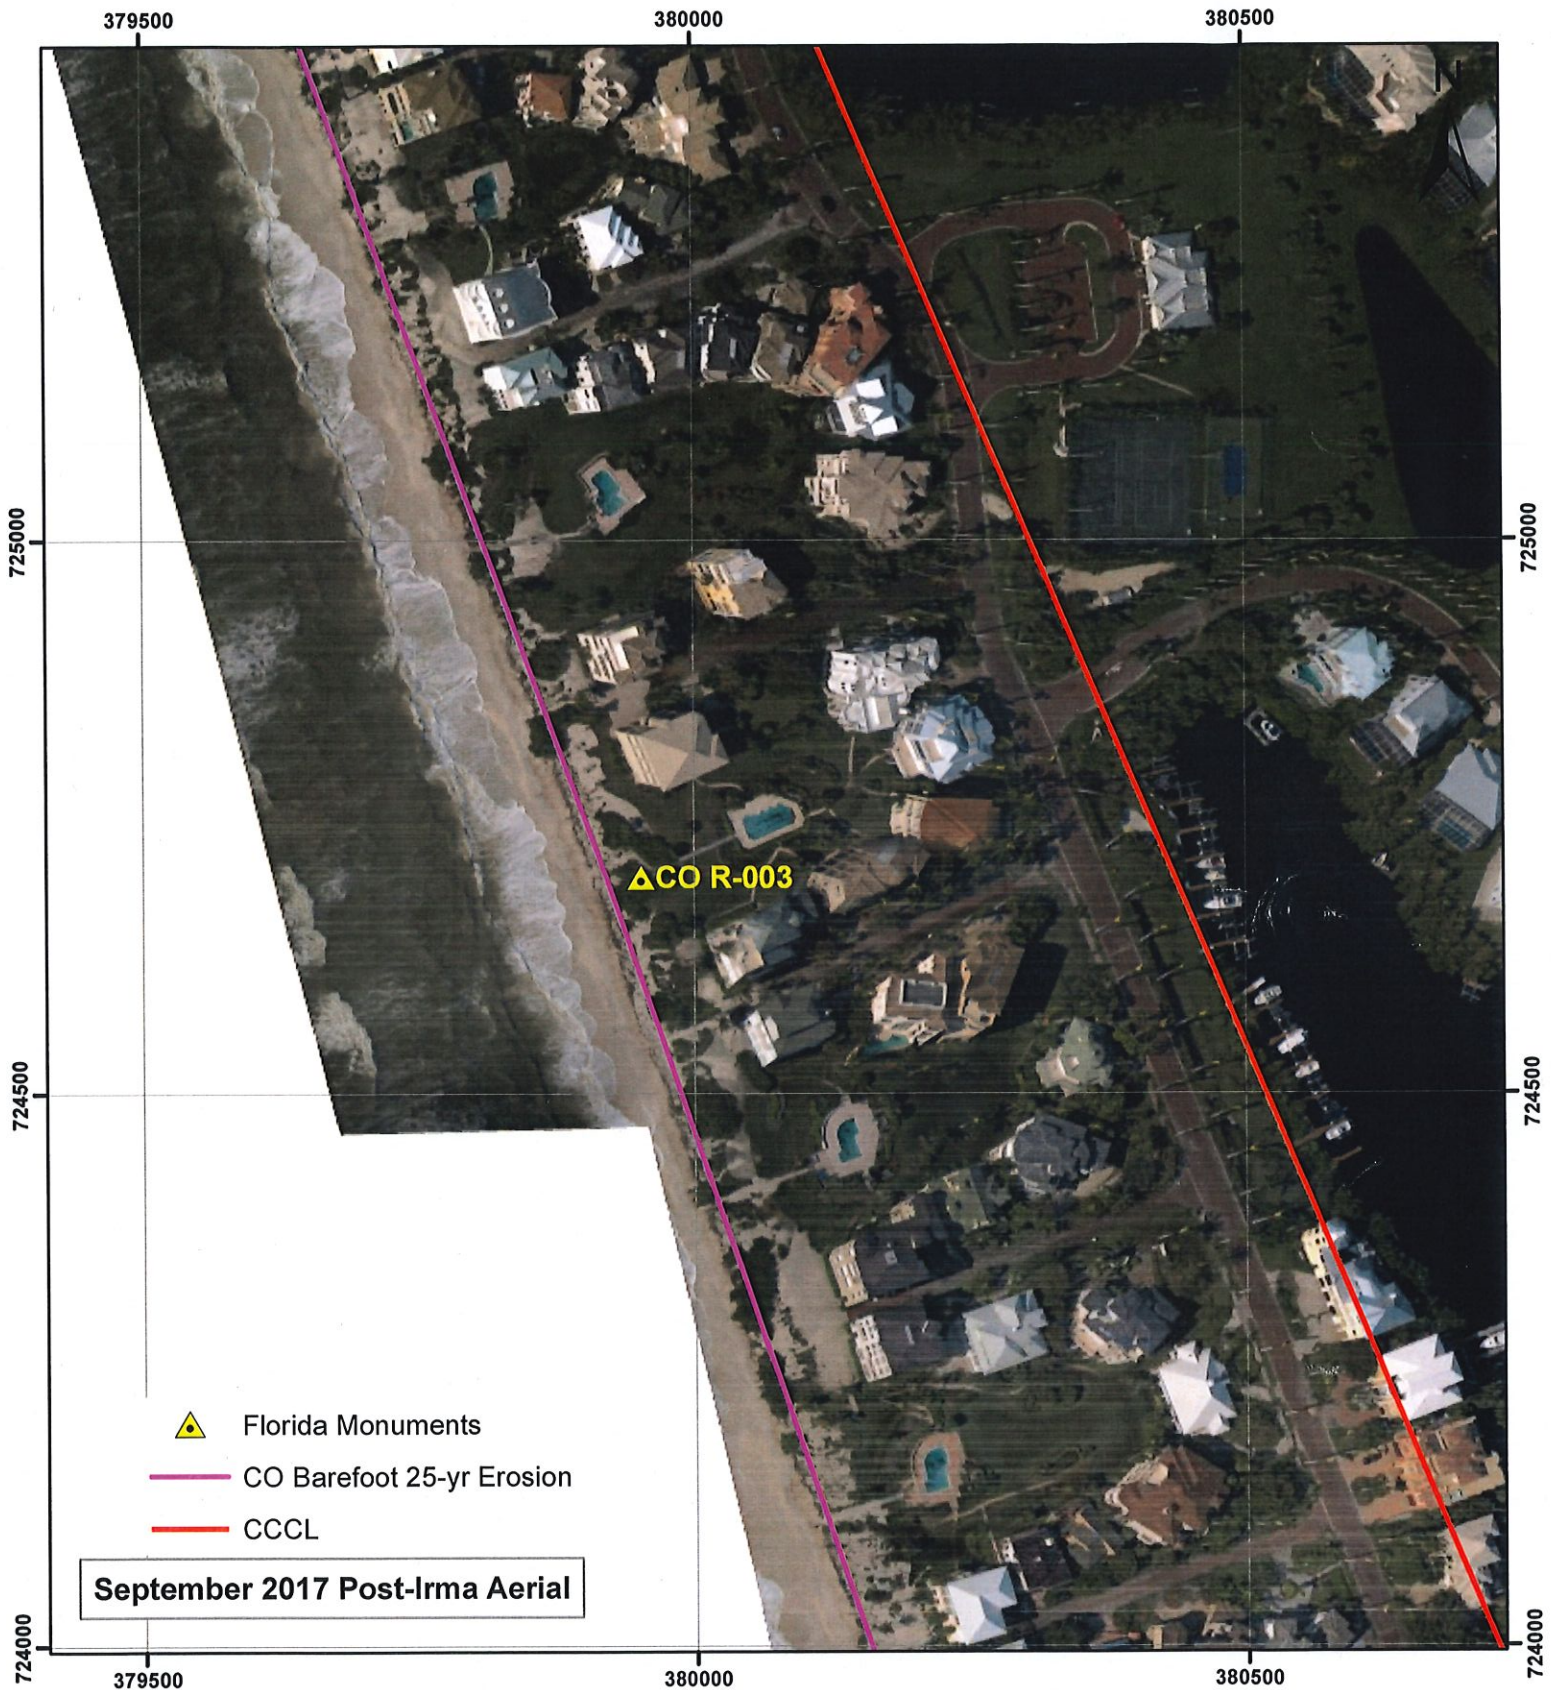
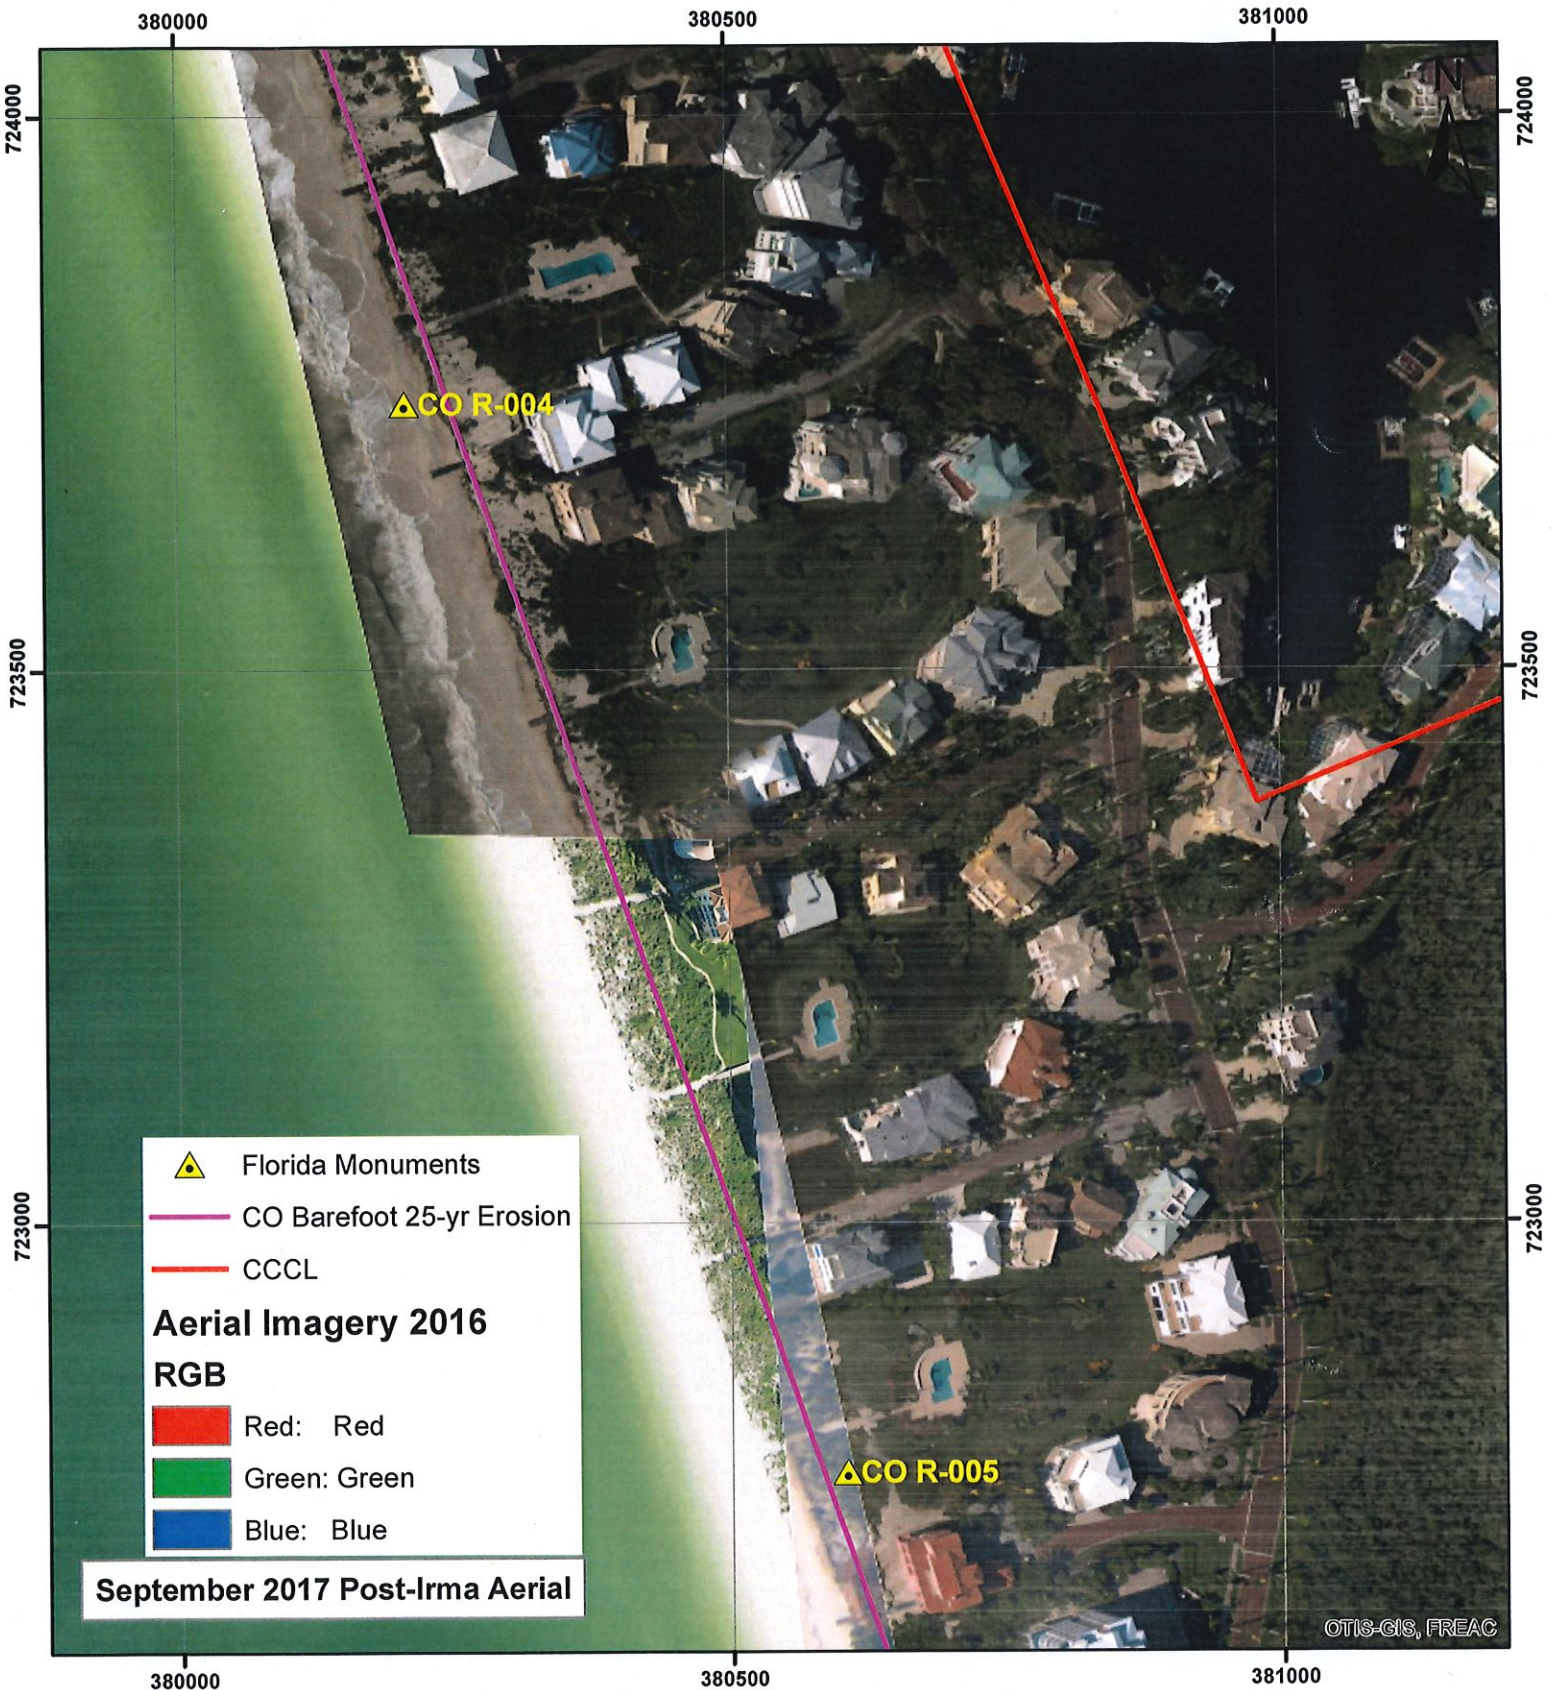
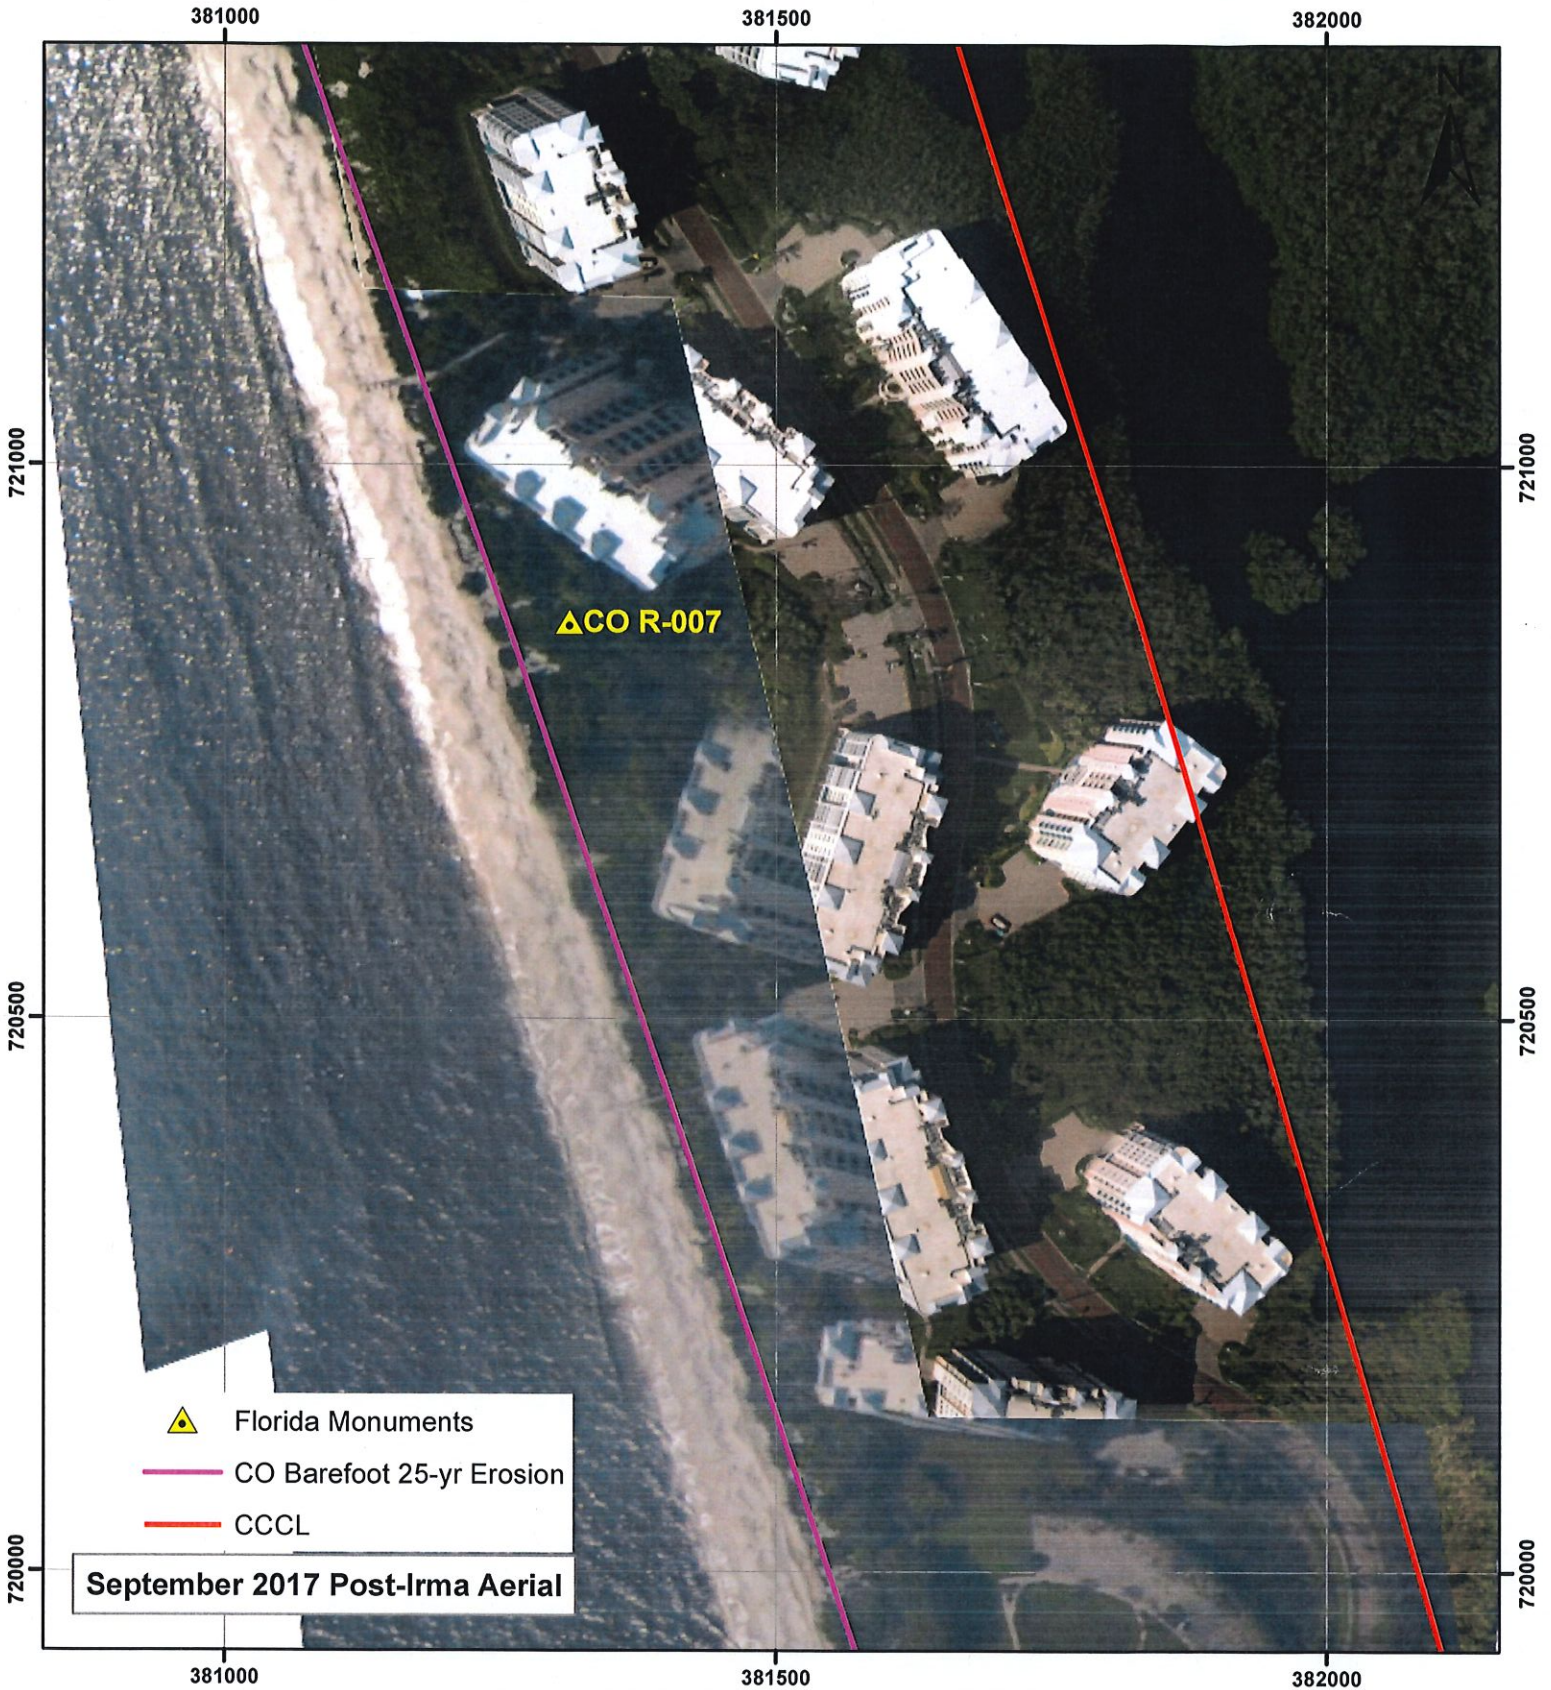
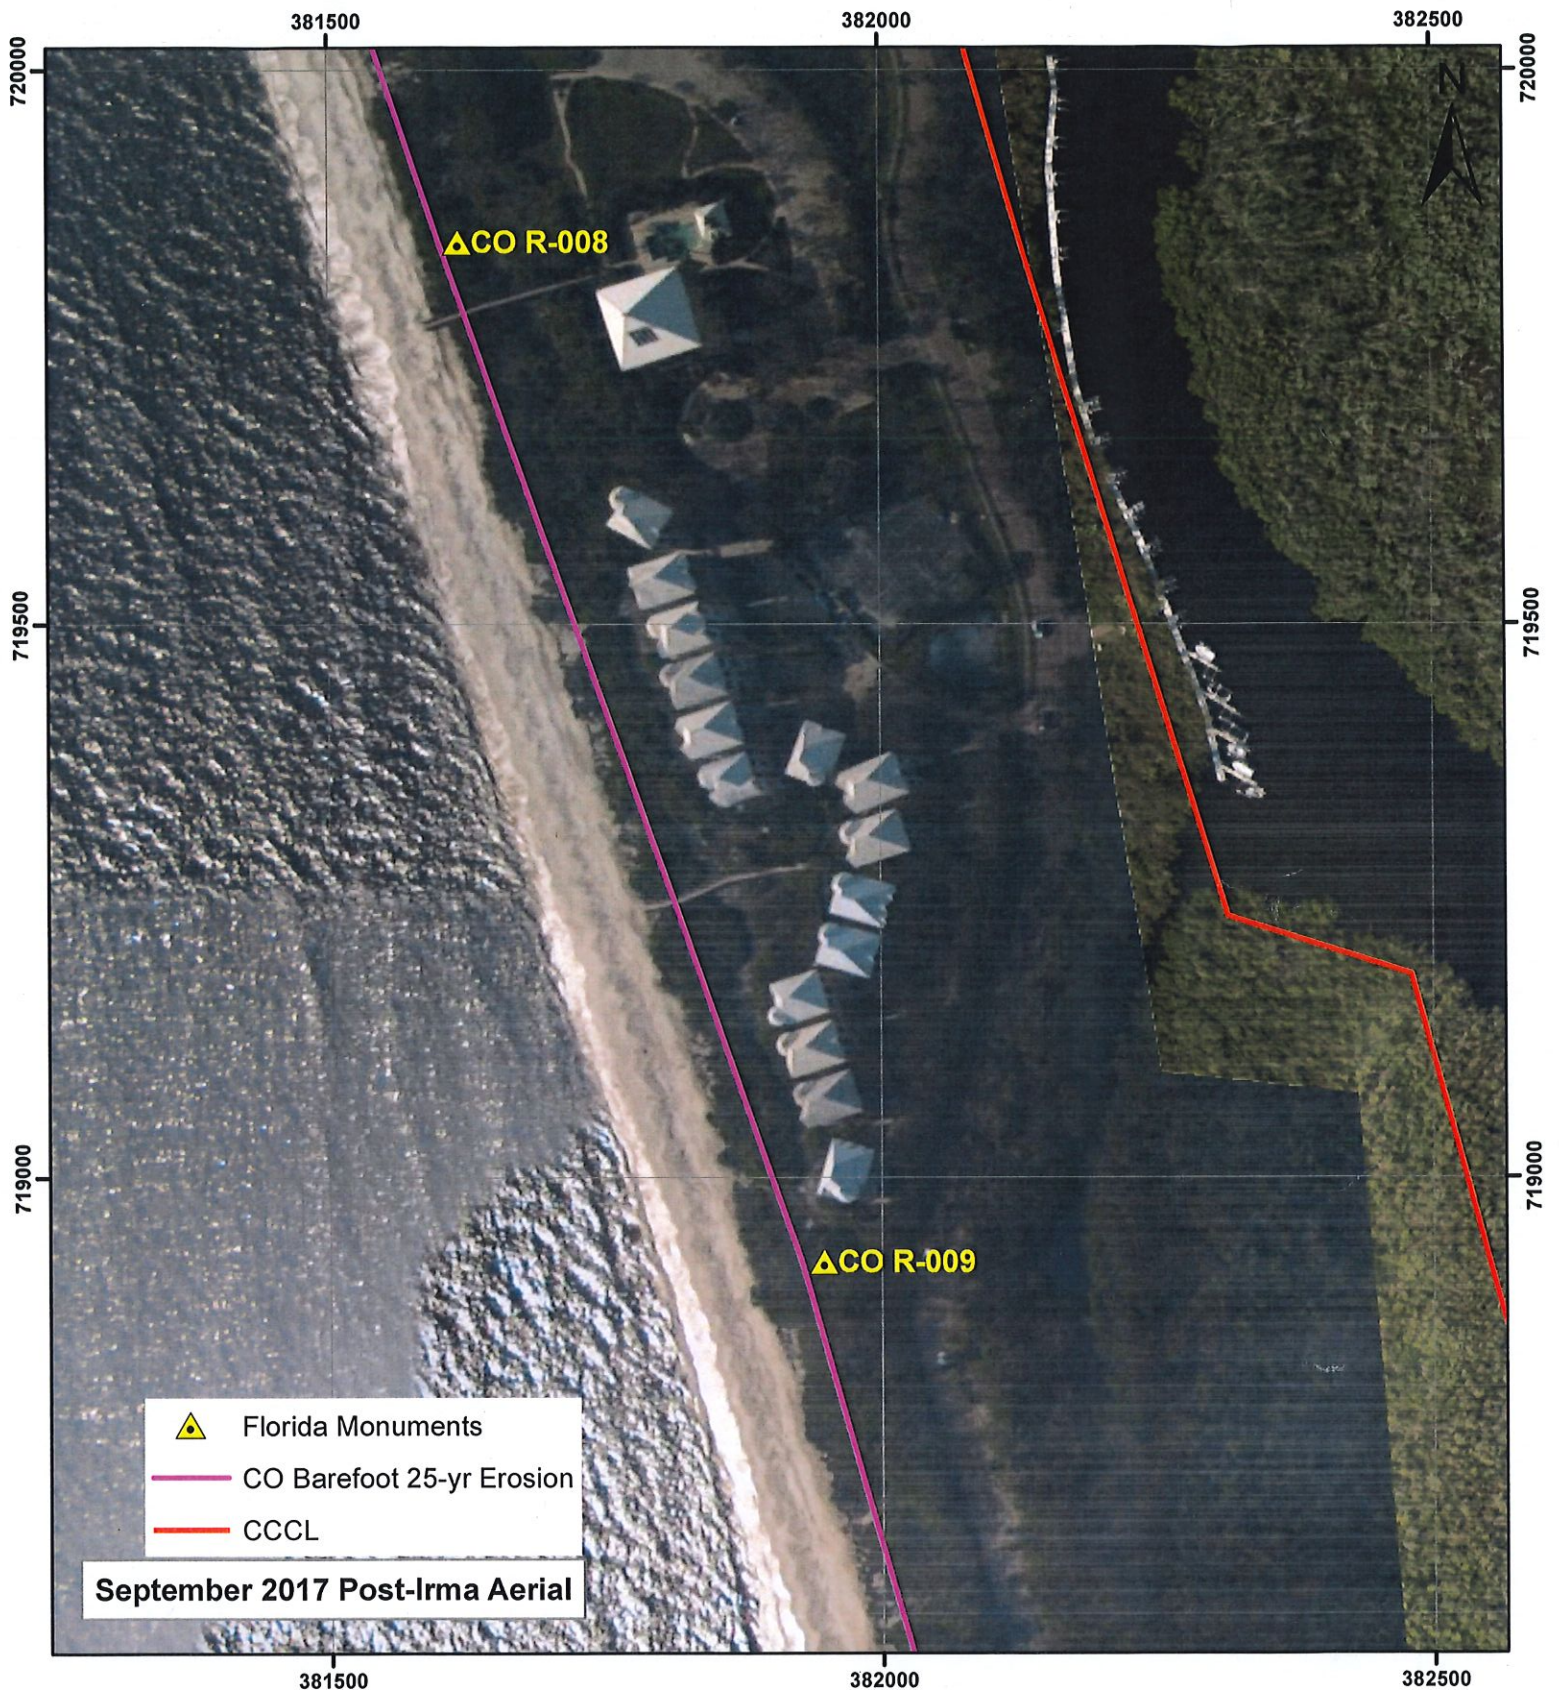
The shoreline change and volumetric comparisons for this segment of Barefoot Beach since the year 2000 reveal a shoreline that exhibits long term stability with fluctuations in erosion and recovery due to the impact of coastal storms. To assist in determining whether this shoreline segment should be recommended to be designated critically eroded, we used the 2017 post-Irma profile data and ran the CCCLa model for a 25-year return interval storm tide event. In the attachment, the results of these computations are plotted on aerial photography for the shoreline segment between R1 and R9. As shown, the erosion of a 25-year storm does not impact the existing development in this area.

Florida Monuments

CO Barefoot 25-yr Erosion

CCCL

September 2017 Post-Irma Aerial
